**DECLARATION OF ERIC HUNTER  
IN RESPONSE TO PLAINTIFF'S  
MOTION FOR PARTIAL SUMMARY  
JUDGEMENT**

RE: Doscher v ransit

Investigative Training Service was asked to review and analyze the available data to determine the bus driver's reaction time, bus speed and distance from the intersection when the northbound traffic signal changed cycles from a green cycle to a yellow cycle. We were also asked to determine the deceleration forces during the braking maneuver in response to the changing traffic signal.

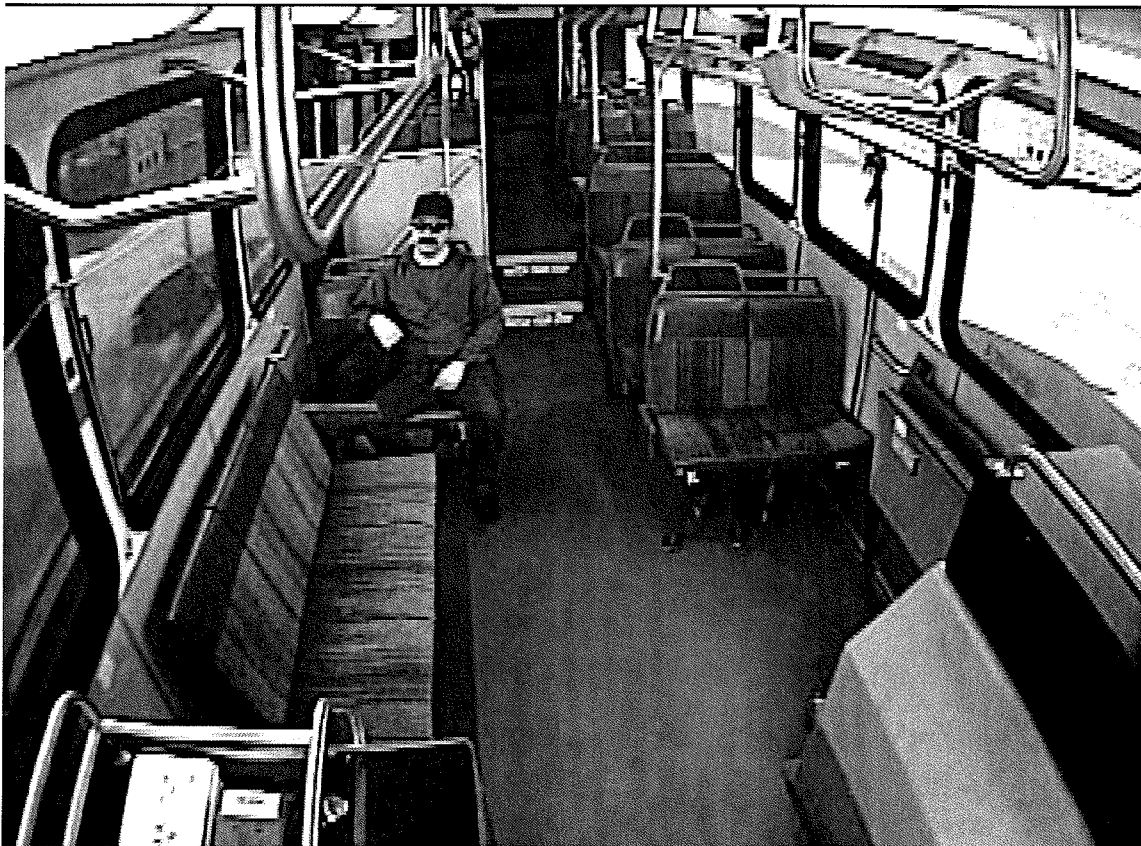
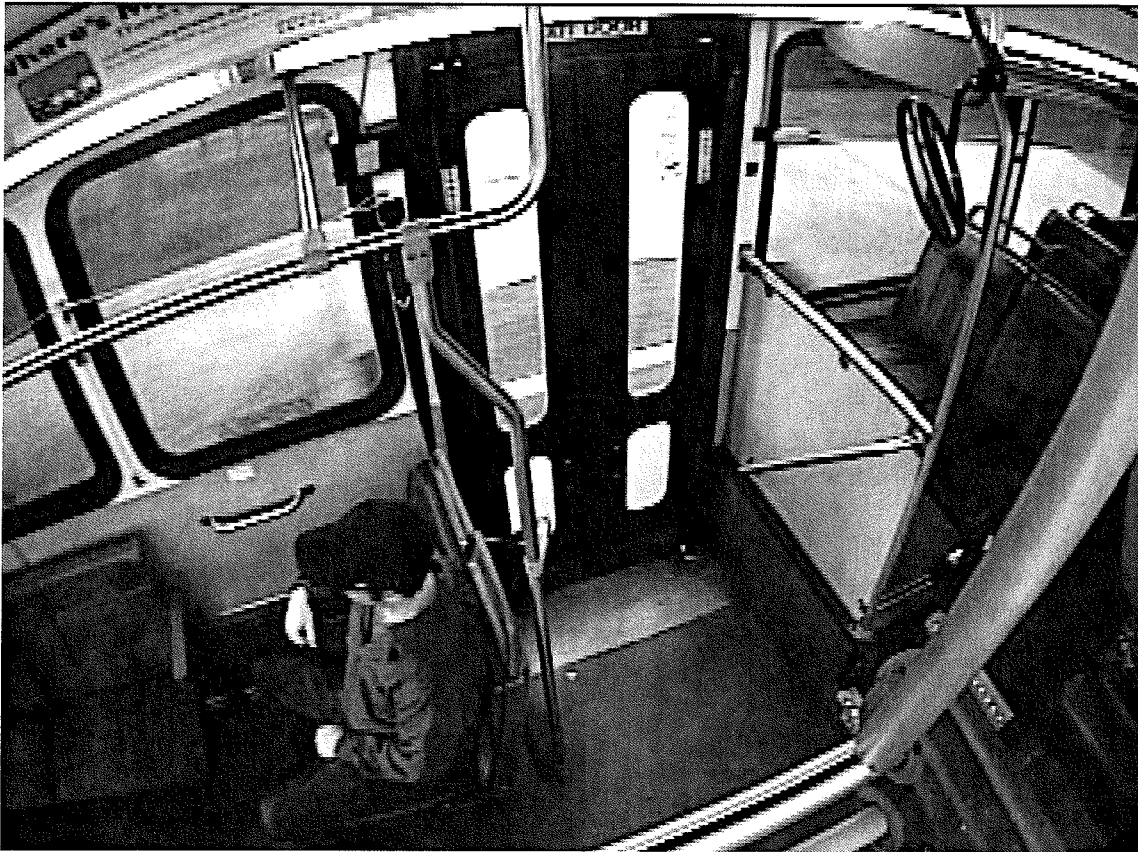
Th Transit onboard bus videos provided valuable information for the incident on February 8, 2016. Before the incident, the bus was traveling northbound in lane 1 (right lane) approaching the intersection. Christian Doscher was seated on the passenger's side of the bus on the inside forward facing seat located just in front of the rear bus door. There was a black backpack in the outside forward facing seat next to Mr. Doscher. Located just forward of this are three inward facing seats with an armrest just in front of Doscher's right knee.

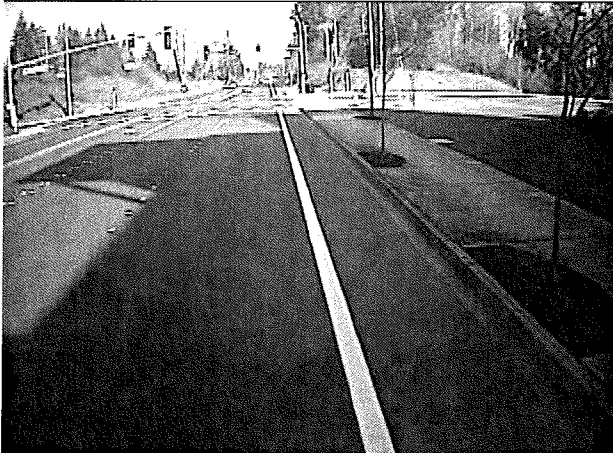
02/08/2016 11:19:21.39  
R440 0627  
Surveillance  
940-52

Green Traffic Signal

There are nine cameras on the \_\_\_\_\_ Bus capturing video at various increments. The camera system has an indicator tied directly to the braking system such that when a minimum of 4 psi of pressure is applied to the brake switch on the bus a “BRAKES” notice will be displayed in the event data for the recording system. This is essentially indicating when the bus driver applies the brakes to the vehicle. The “Road” camera was mounted at the front of the bus showing the view outside of the front windshield. Although pixilated, the northbound traffic signal can be seen changing from a green signal to yellow at time 11:19:21.50. The “BRAKES” notice first appears in the event data at the time of 11:19:22.03, essentially 0.53 seconds after the traffic signal has changed from a green signal to a yellow. This is a very fast response time by the bus driver as studies show that the average perception and reaction time for a driver to apply the brakes on a vehicle in response to a yellow traffic signal change is approximately 1.0 seconds.<sup>1</sup> In my opinion, the \_\_\_\_\_ bus driver had a response time less than average and was able to apply the brakes quicker than most drivers faced with the same scenario. The images below show the traffic signal change. The length of the yellow traffic signal would match the traffic light timing of 3.5 seconds as the signal remains yellow until moving out of the camera view at the time 11:19:24.94.<sup>2</sup>

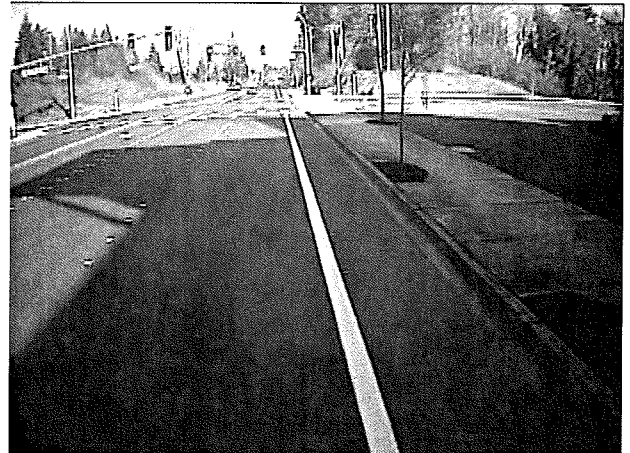
02/08/2016 11:19:21.50  
R440 0627  
Surveillance  
940-52

Yellow Traffic Signal

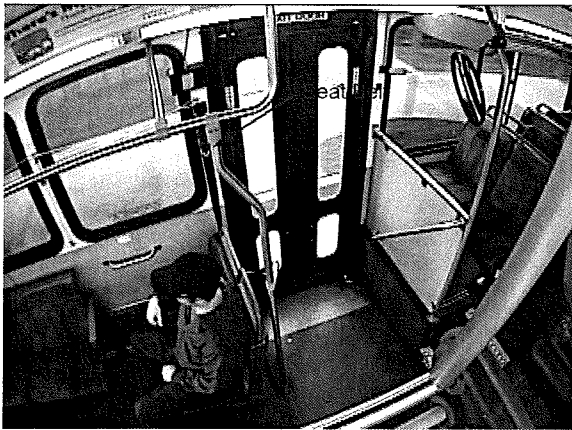
02/08/2016 11:19:22.19  
R440 0627  
Surveillance  
940-52

Brakes

The initial travel speed and average deceleration of the Transit bus was calculated by inspecting and measuring the scene and the bus involved in the incident. The first step was to determine the brake lag for the air-brake system on the bus. Brake lag is an inherent property of the air-brake system common on buses and tractor-trailer combinations and is the time from when the brake pedal is depressed until the vehicles tires start braking. Typical brake lag on these type of heavy vehicles range from 0.25 to 0.5 seconds. Knowing that the bus driver had stepped on the brake pedal at the time of 11:19:22.03, the various cameras were reviewed in an attempt to observe the first point at which deceleration, or slowing, of the bus occurred. The best indicator of this was a seat belt mounted on the passenger's side of the bus on the paneling just forward of the rear door and next to Mr. Doscher. It is my understanding that this was a seat belt used for securing passengers operating a wheelchair. The "Rear Door" camera has a good perpendicular view of the long, vertical seat belt, and shows the start of the bus deceleration. As the bus decelerates, or slows, objects within the bus will move forward slightly due to their inertia. Although it is subtle, the seat belt can be seen starting to move slightly forward at the time of 11:19:22.29, approximately 0.26 seconds after the bus driver has applied the brakes. For purposes of my analysis I have used a 0.25 second brake lag for my calculations.

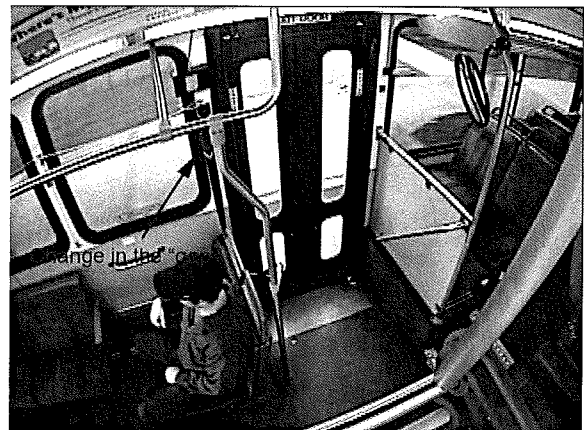
02/08/2016 11:19:22.29  
R440 0627  
Surveillance  
940-52

Brakes

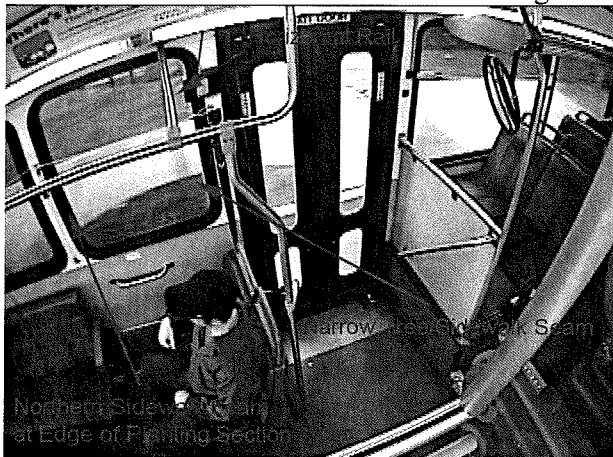
I next determined how far the bus traveled and how much time passed from when the “BRAKES” notice was first displayed until the bus stopped its forward movement. The best indicator of this was also the “Rear Door” camera. Due to the camera mounting location there is a horizontal hand bar that extends essentially perpendicular from the viewpoint of the camera to the passenger’s side of the bus. This creates a good measuring line as the roadside objects and environment can be seen through the window below the horizontal hand rail. When the “BRAKES” notice is first displayed the horizontal hand rail appears to be in-line with either a narrow tree in the center of a shoulder planting section and/or a sidewalk seam that is at the same general location.

As can be seen in the photograph above, this location was marked with a cone for reference during the scene inspection. The forward movement of the bus stops at the time of 11:19:26.30. This same horizontal hand rail was used to determine the approximate stopped position of the bus.<sup>3</sup> The rail is almost in-line with a sidewalk seam just south of the crosswalk cut-out for the southern crosswalk at the intersection. This location was also marked with a cone for reference during the scene inspection. This distance between these two cones (representing the distance from when “BRAKES” were initially applied to the stopped position of the bus) was approximately 115 feet. The total time elapsed for this was 4.27 seconds.<sup>4</sup>

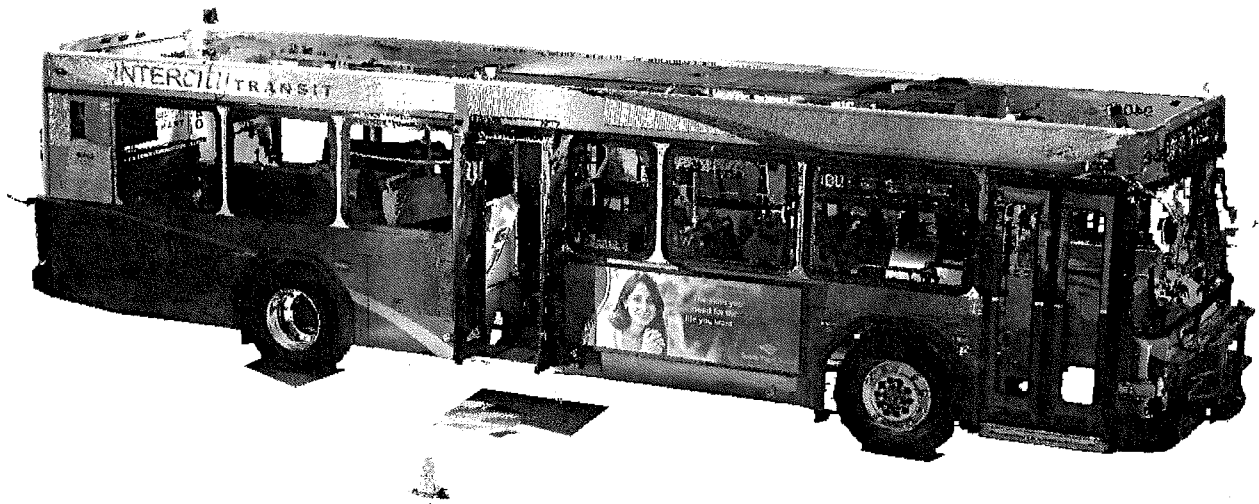
The Transit bus was scanned with a FARO laser scanner to measure the relative dimensions on the vehicle and determine the relative location of the “Rear Door” camera to the horizontal hand bar used for the camera and scene analysis. The camera location is almost directly perpendicular to the horizontal hand bar, validating that this camera view is a good resource to measure the roadside objects and place the bus location on the roadway at specific time intervals.
